# Building a Dam and Irrigation System to Help Farmers in Isabela, the Philippines, Adapt to Climate Change, 2011–18

Climate Change–Resilient Agriculture

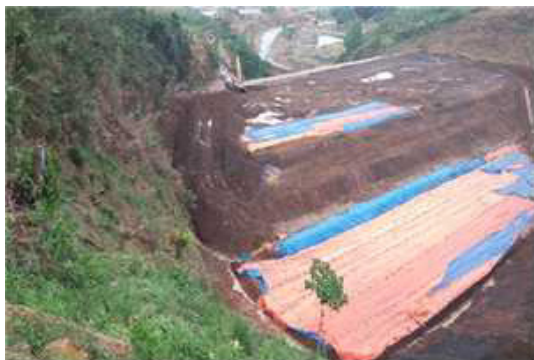
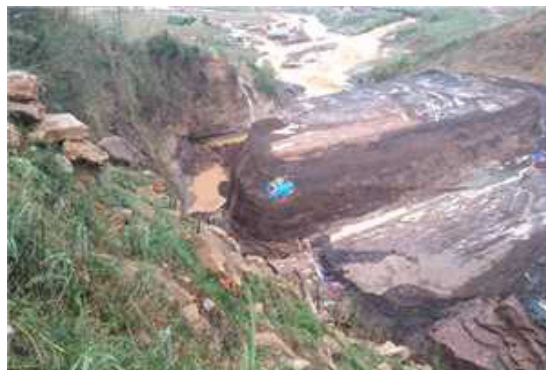
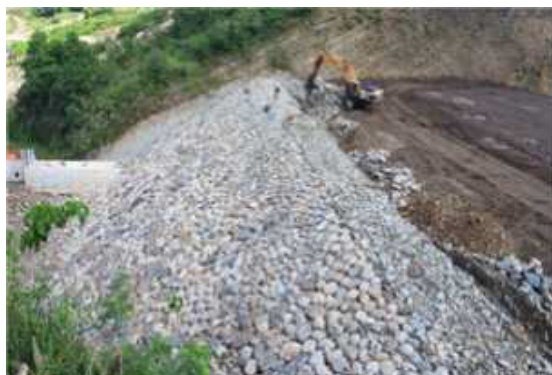
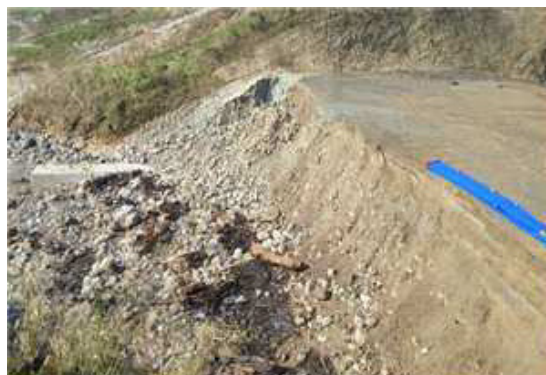
**FIGURE 2. DAM CONSTRUCTION BEFORE AND AFTER TYPHOON HAIMA****a. Before (Dam body-center filled part)**

The dam body and spillway slope swept away because of the excessive overflows, although the construction team installed additional drainage along with the planned emergency installations for typhoon and flooding.

But the worst weather was yet to come. In October 2016, Typhoon Haima (called Super Typhoon Lawin in the Philippines) hit Isabela, causing extensive damage to the almost-completed dam (see figure 2). The project team had prepared for typhoons and had emergency protocol procedures in place, but the typhoon hit with far more strength than anyone had anticipated. “We were expecting to use the irrigated water for farming soon by that time because the construction was being finalized,” said one farmer from Pasa. “The typhoon delayed construction and caused us great distress.” It took more than four months to repair the damages and cost nearly US\$1 million.
